Manhole Inspection Summary

Manhole # S11MM_041MH

Insp Date: **1/21/09 11:51 AM**

Location Address: **2400 N ELLAMONT**

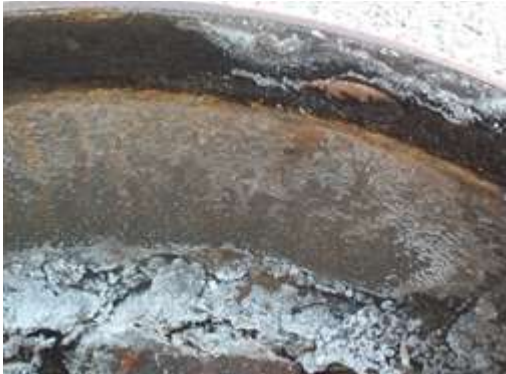
Defect 5

Offset: **5** (in.)

FRAME OFFSET

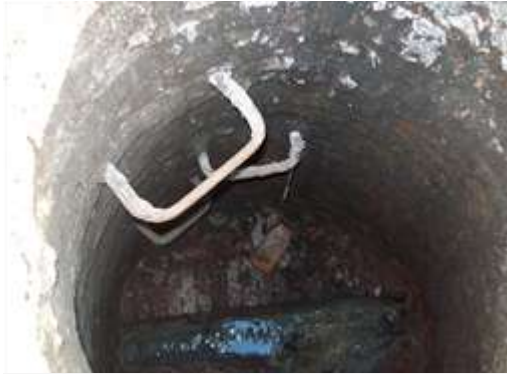
Defect 1

☒ **Evidence Of Surcharge** Depth: **4** (ft.) ☐ Active Surcharge Present

EVIDENCE OF SURCHARGE

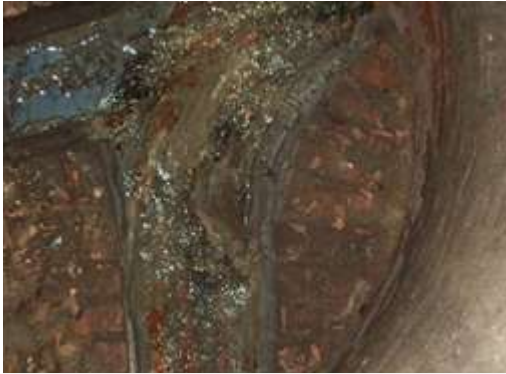
Defect 4

Condition: ☐ Sound ☐ Cracked ☐ Root Intrusion ☐ Deteriorated ☐ Leaks ☒ **Debris**

DEBRIS IN CHANNEL

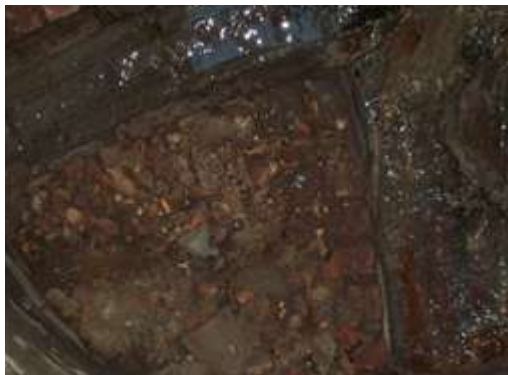
Defect 3

Condition: ☐ Sound ☐ Cracked ☐ Root Intrusion ☐ Deteriorated ☐ Leaks ☒ **Debris**

DEBRIS ON BENCH

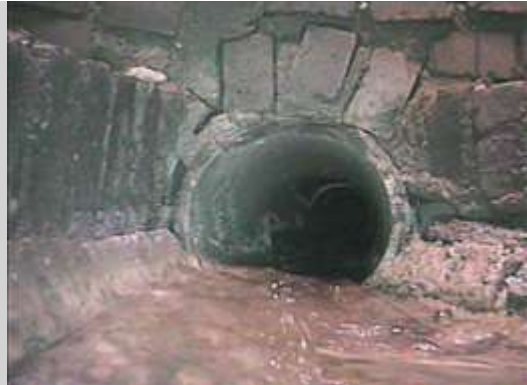
12 O'Clock Outflow

Pipe Height: (in.) Direct
Pipe Material: **Clay** ☐ Pipe Lined
Invert Depth: **7.85** (ft.) Flow Characteristics: **Slow**
Deposits: ☐ None ☒ Mud ☒ Sludge ☒ Debris ☒ Grease
Silt Depth: **8** (in.) Deposits Extent: **Heavy**
Infiltration: **None** Pipe Seal Cond: **Broken**

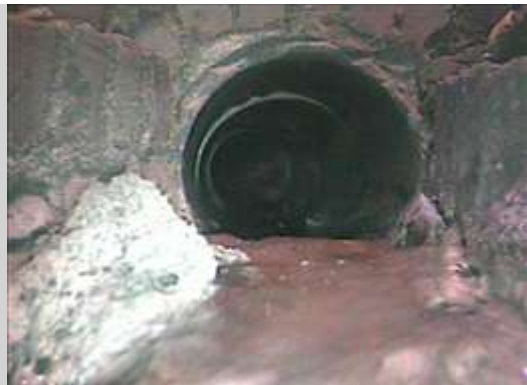
3 O'Clock Inflow

Pipe Height: (in.) Direct
Pipe Material: **Clay** ☐ Pipe Lined
Invert Depth: **7.80** (ft.) Flow Characteristics: **Slow**
Deposits: ☐ None ☒ Mud ☒ Sludge ☒ Debris ☒ Grease
Silt Depth: **8** (in.) Deposits Extent: **Heavy**
Infiltration: **None** Pipe Seal Cond: **Broken**

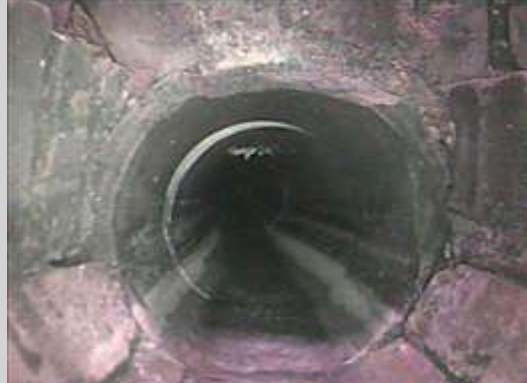
6 O'Clock Inflow

Infiltration: **None** Pipe Seal Cond: **Broken**
